**FINAL REPORT FOR  
FOCUSED GROUNDWATER  
CHARACTERIZATION  
ALASKA REAL ESTATE PARKING LOT  
ANCHORAGE, ALASKA**

**ADEC SPAR TERM CONTRACT #18-8036-13  
SEPTEMBER 16, 2014**

ADEC Site Name: Alaska Real Estate Parking Lot  
ADEC File No: 2100.38.434

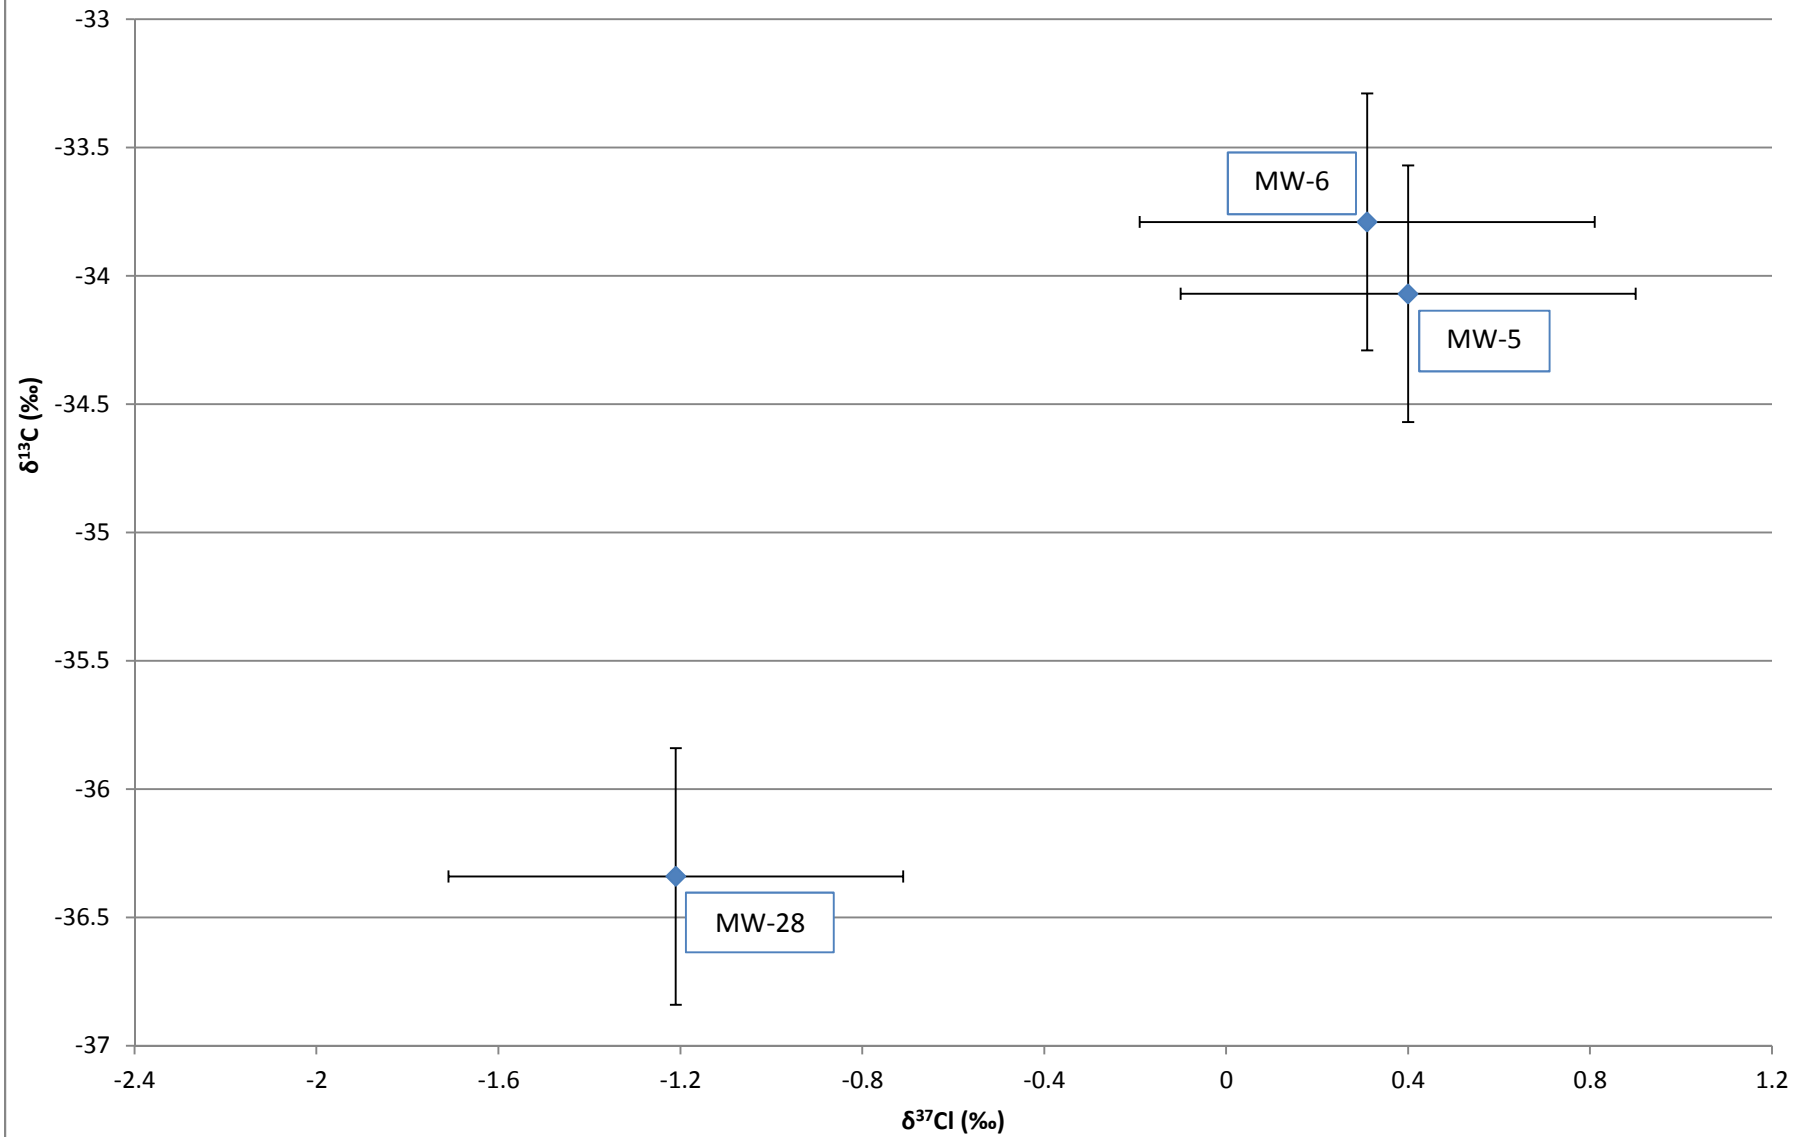
**Chart 2: Analysis of  $\delta^{13}\text{C}$  and  $\delta^{37}\text{Cl}$  in PCE  
Alaska Real Estate Parking Lot, Anchorage, Alaska**

Carbon and chlorine isotopic signatures in PCE at various plume locations may be plotted versus one another for two dimensional analysis. Carbon and chlorine isotopic signatures may have a linear relationship (straight line on a bivariate plot) if results arise from the same source, and degradation proceeds at similar rates throughout a monitoring well network. Deviations from the linear relationship are caused by different sources or changes in degradation mechanisms and rates. Chart 2 shows a two dimensional analysis of  $\delta^{13}\text{C}$  and  $\delta^{37}\text{Cl}$  in PCE for MW-5, MW-6, and

In the known source area, carbon isotopic signatures at MW-5 and MW-6 were  $-34.07\text{‰}$  and  $-33.79\text{‰}$ , respectively. Chlorine isotopic signatures at these monitoring wells were  $0.4\text{‰}$  and  $0.31\text{‰}$ , respectively. Generally, when the isotopic signatures of carbon are within  $0.5\text{‰}$  of one another, as they are for MW-5 and MW-6, the samples can be considered to represent the same source material, likely with little or no biodegradation occurring along the flow-path between the two wells.

MW-28 in the Ship Creek area had a carbon isotopic signature of  $-36.34\text{‰}$  and a chlorine isotopic signature of  $-1.21\text{‰}$ , both of which are significantly lighter than the corresponding isotopes at MW-5 and MW-6. Therefore the data suggests either a different source, or that the PCE at MW-5 and MW-6 has undergone more degradation than the PCE observed at MW-28.

In summary, CSIA results show PCE with heavier isotopic signatures at MW-5 and MW-6 in the source area than at MW-28 in the Ship Creek area. In other words, if both areas of contamination were caused by the same source, PCE remaining at MW-5 and MW-6 is more degraded than PCE remaining at MW-28. However, geochemical parameters and microbial population analyses show that conditions at MW-28 are more conducive to reductive dechlorination. Therefore it is expected that PCE at MW-28 would be more degraded than PCE at MW-5 and MW-6 if both were caused by the same source.

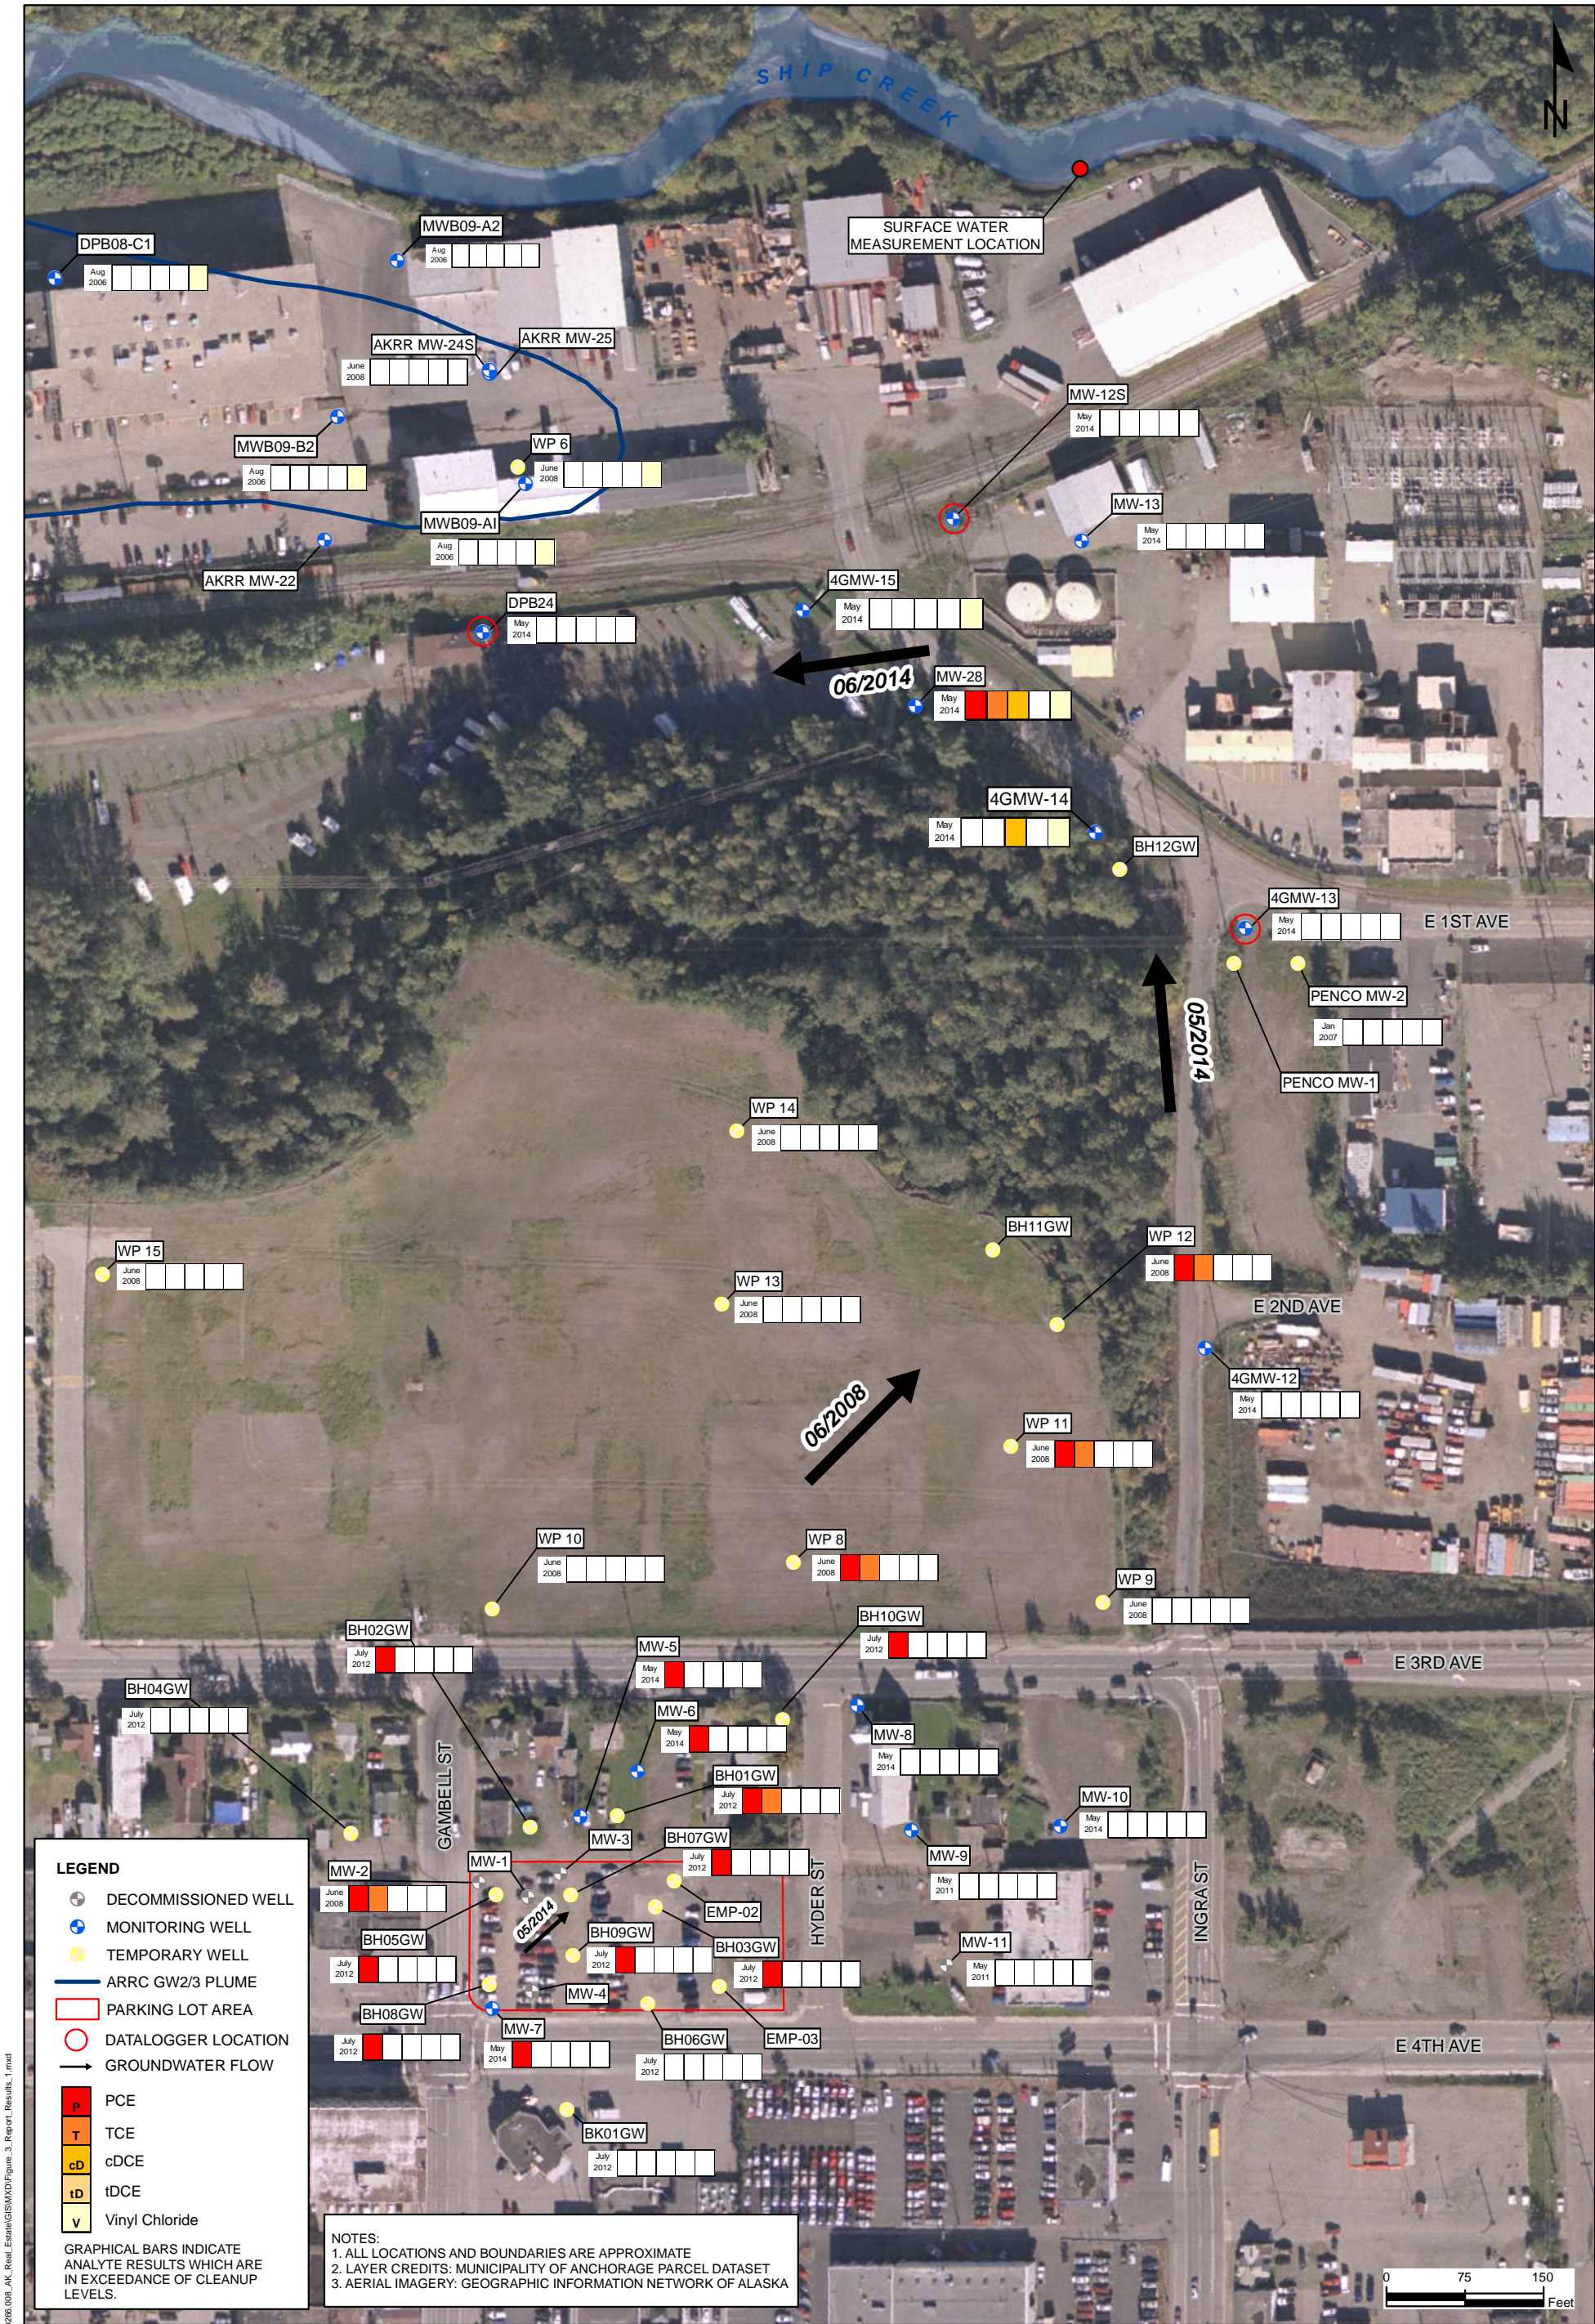
FOCUSED GROUNDWATER CHARACTERIZATION  
ALASKA REAL ESTATE PARKING LOT, ANCHORAGE, ALASKA

These data are shown in Table 4, along with the most current data available for each location represented on Figure 3. There are not sufficient historic data points to analyze results over time; the data are not used to determine trends. However, these data indicate that degradation is not occurring within the source area as PCE remains at concentrations consistent with the previous results from 2007 and 2008 and none of the degradation products of PCE were detected.

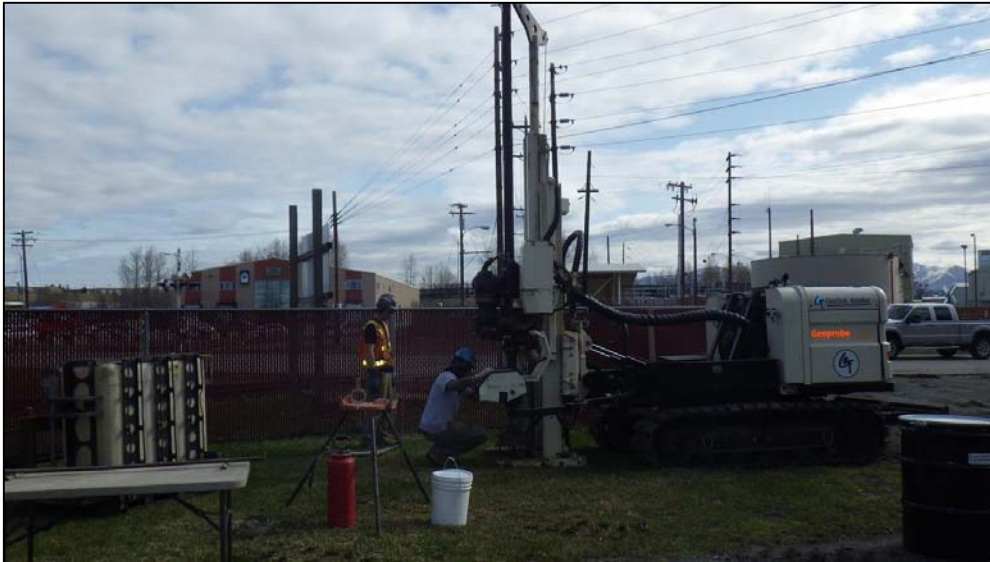
Photograph 1: Drilling monitoring well 4GMW-15 at the Ship Creek RV Lot using a GeoProbe 8040 direct push drilling rig. Looking east.

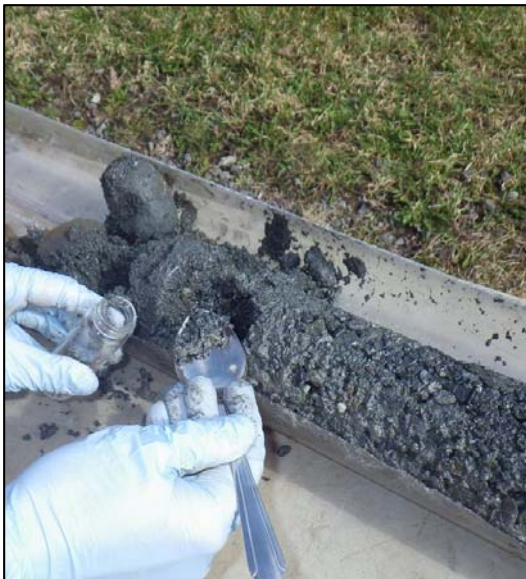
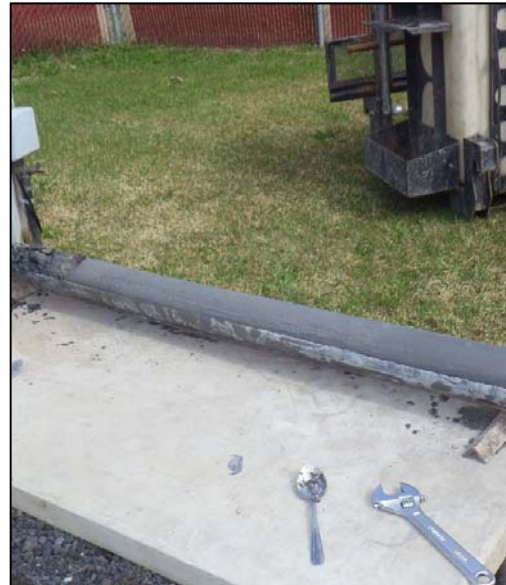
Photograph 2: Soils encountered during installation of well 4GMW-15 – sandy gravel to sand, to Bootlegger clay. Collecting soil for ColorTec screening.

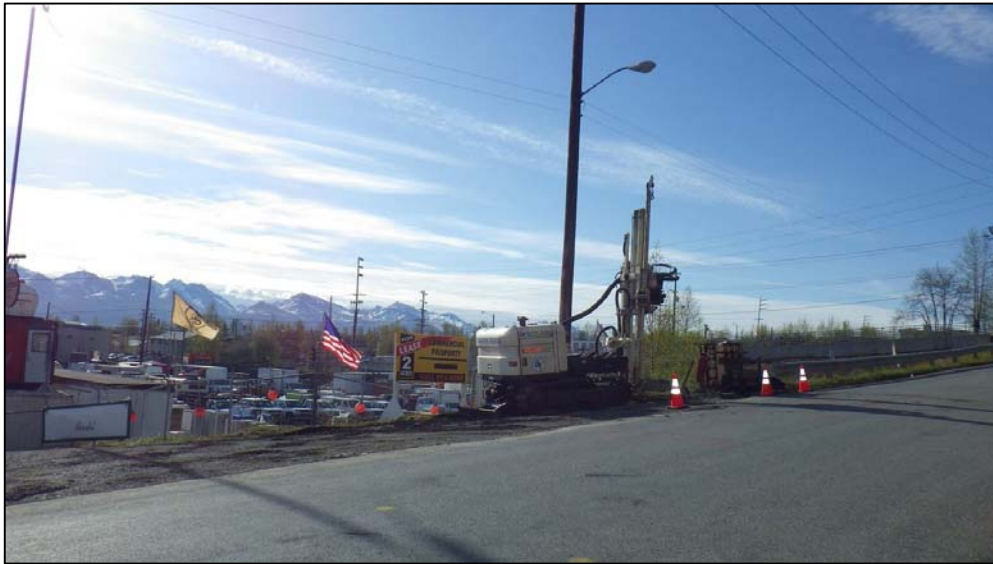
Photograph 3: Drilling monitoring well 4GMW-12 near Grubstake Auction lot using a GeoProbe 8040 direct push drilling rig. Looking southeast.

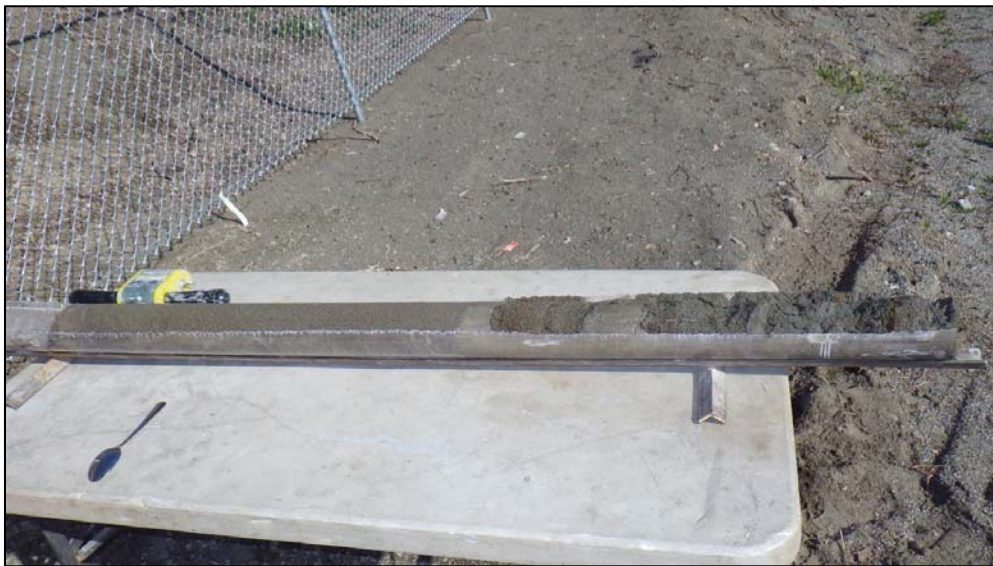
Photograph 4: Soils encountered during installation of well 4GMW-12. Well sorted medium-grained sands to Bootlegger clay.

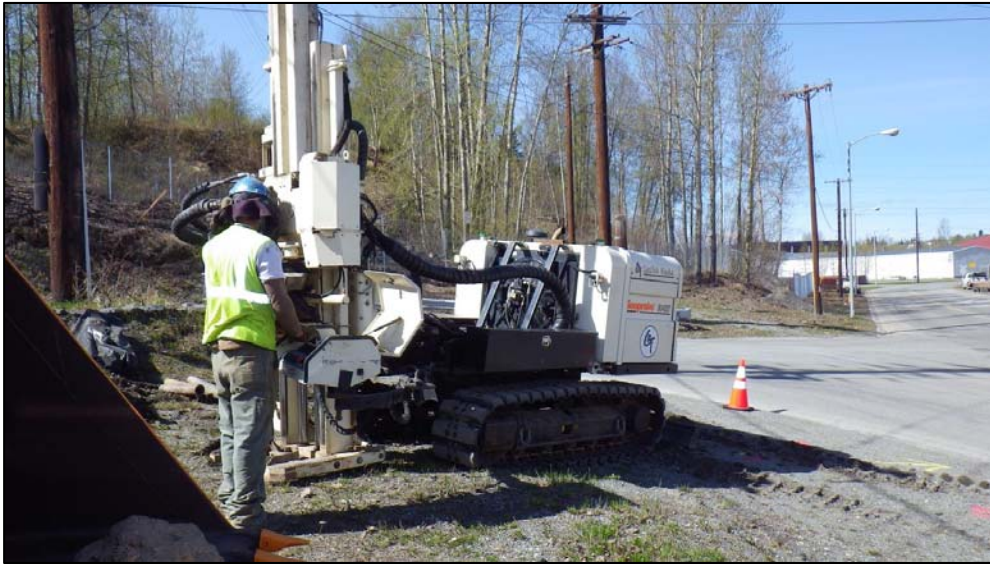
Photograph 5: Drilling monitoring well 4GMW-13 near former PENCO well MW-1.  
Looking west.

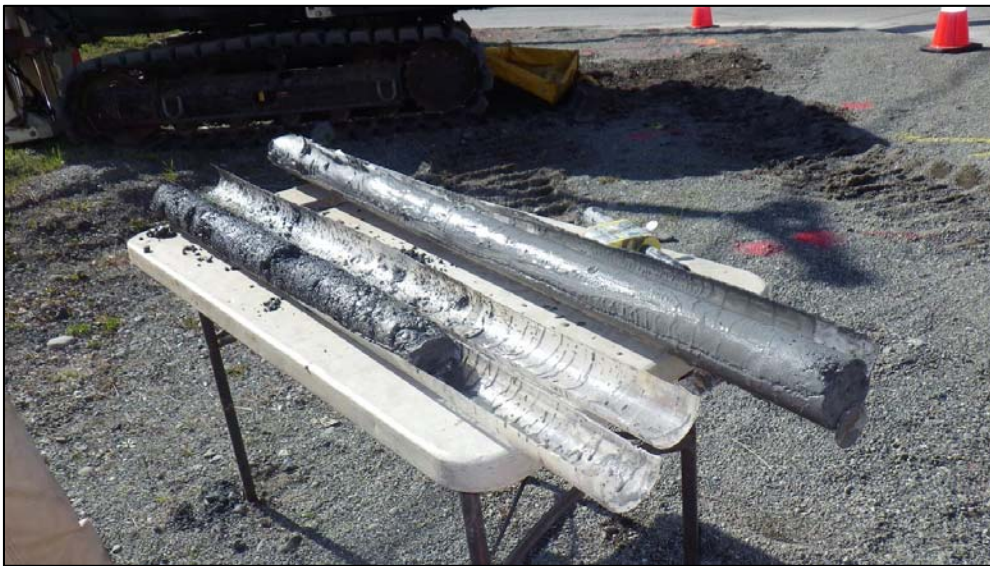
Soil was recovered from borehole 4GWM-13 from 10 to 20 feet bgs. Color-Tec screening samples were collected at 10, 13, 15, 16, and 19 feet bgs. The Bootlegger clay confining layer was reached at 15 feet bgs. Petroleum impacts were noted in all recovered soil based on olfactory and visual screening.

Photograph 6: Soils encountered during installation of well 4GMW-13. Sandy gravel  
with petroleum impacts to Bootlegger clay.

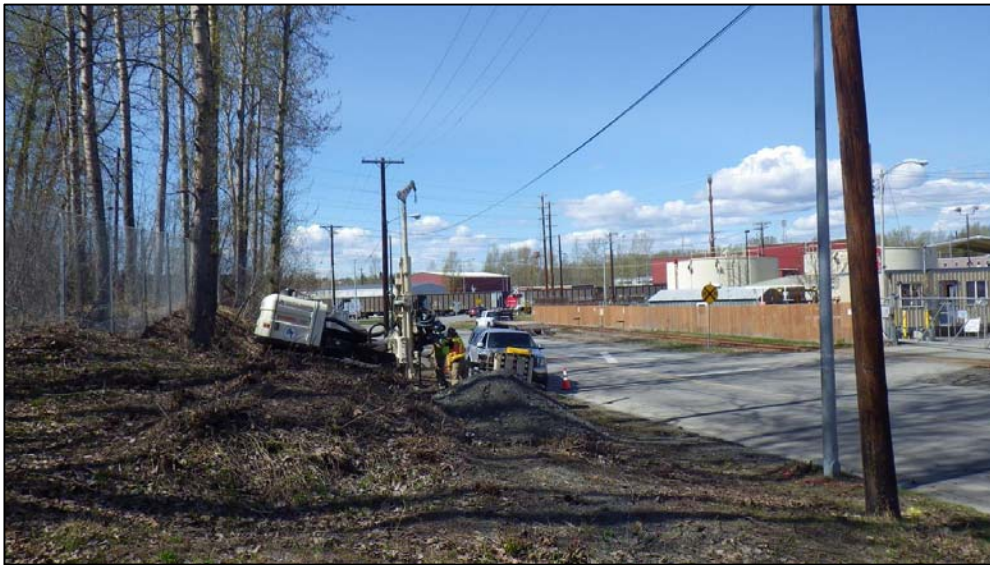
Photograph 7: Drilling monitoring well 4GMW-14. Looking northwest.

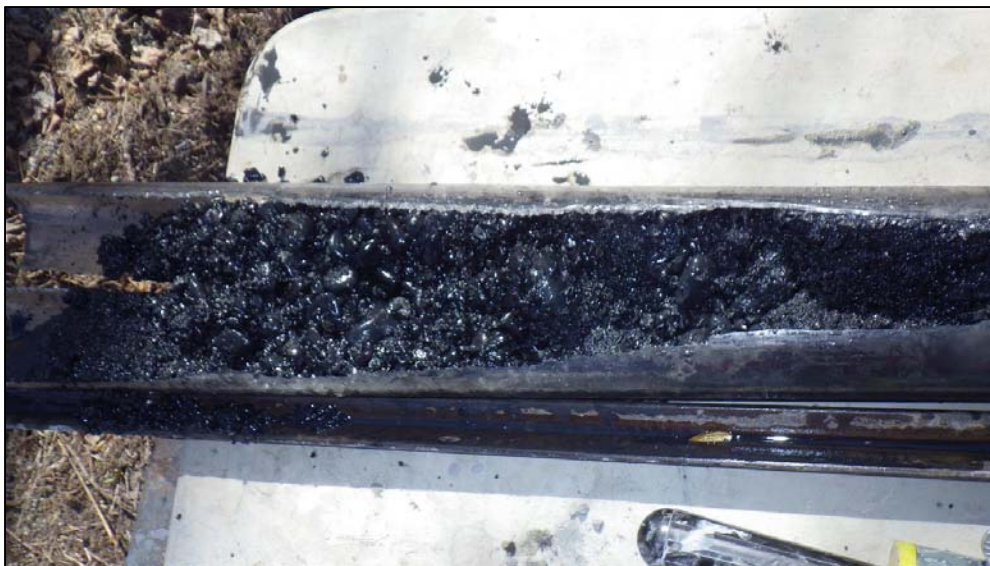
Soil was recovered from borehole 4GWM-14 from 5 to 15 feet bgs. Color-Tec screening samples were collected at 10, 11, 13, and 13.5 feet bgs. The Bootlegger clay confining layer was reached at 13.5 feet bgs. Petroleum impacts were noted in all recovered soil based on olfactory and visual screening. Blebs of fuel were visible on the plastic sleeve.

Photograph 8: Soils encountered during installation of well 4GMW-14. Sandy gravel impacted with petroleum.

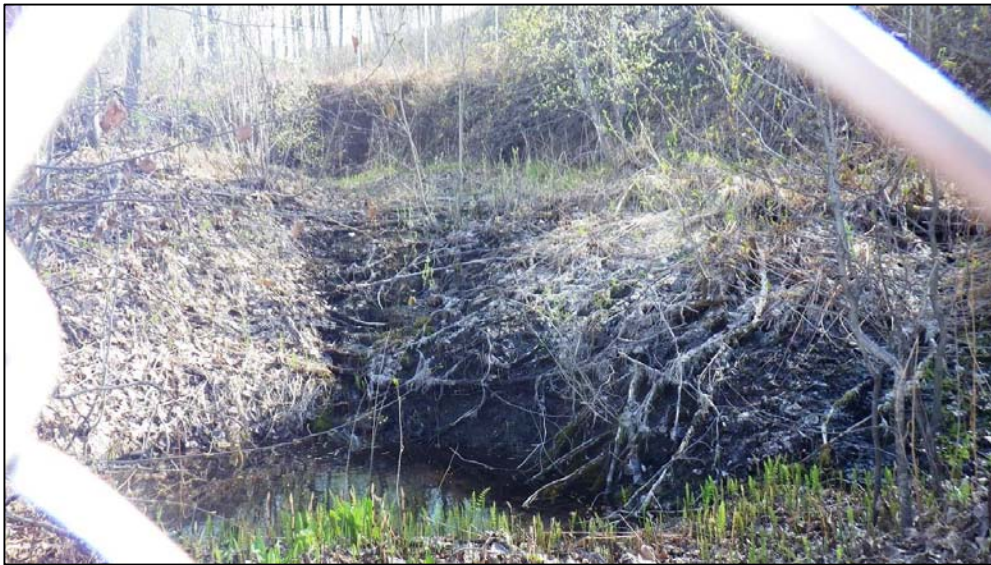
Photograph 9: Pool of water located behind former Alaska Native Hospital fencing located just south of monitoring well 4GMW-14. Looking south.

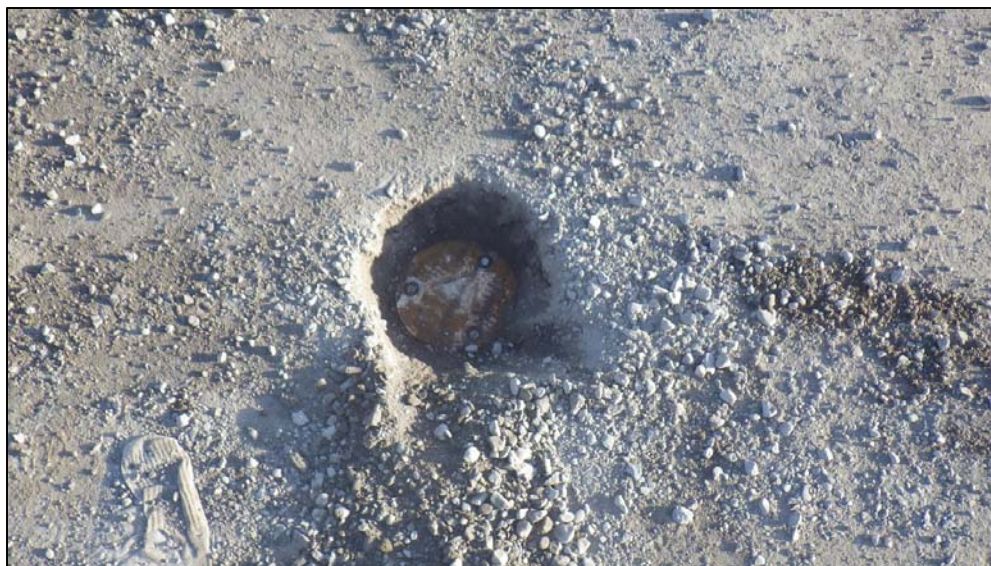
At MW-3, the lid of the flush monument was intact, but the sidewalls had been crushed inward. The PVC well cap was present but was loosely placed atop of the PVC. Only 7 feet of the original 45 feet of depth was clear; the bottom 38 feet of the well, including the screened interval, was filled and the bottom of the well was not able to be removed. The remaining 7 feet was filled with bentonite chips hydrated in place. The flush monument was removed, disposed, and the area was backfilled with pea gravel and native material flush with the parking lot surface.

Photograph 10: Condition of MW-3 prior to decommissioning.

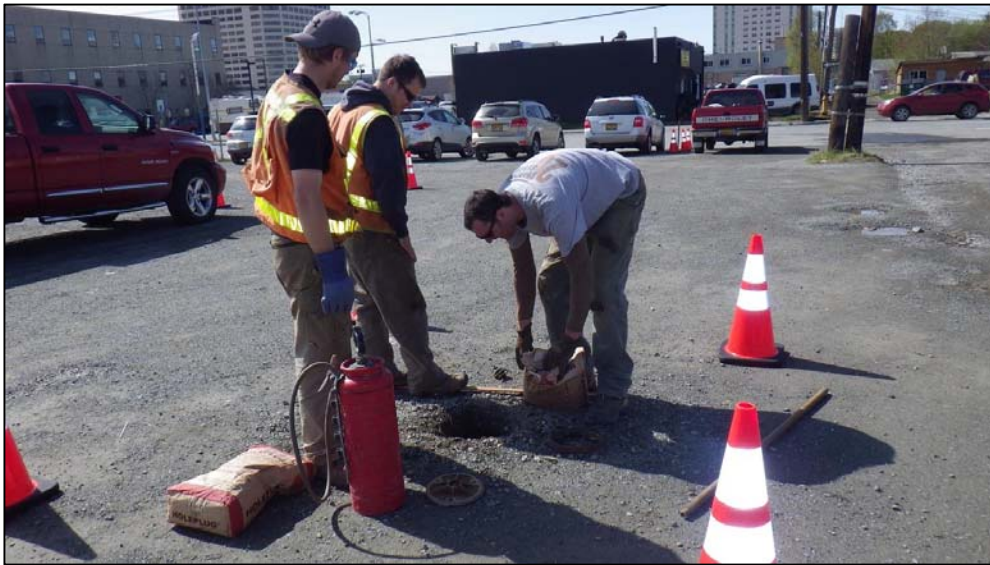
Photograph 11: Decommissioning MW-3. Looking west.

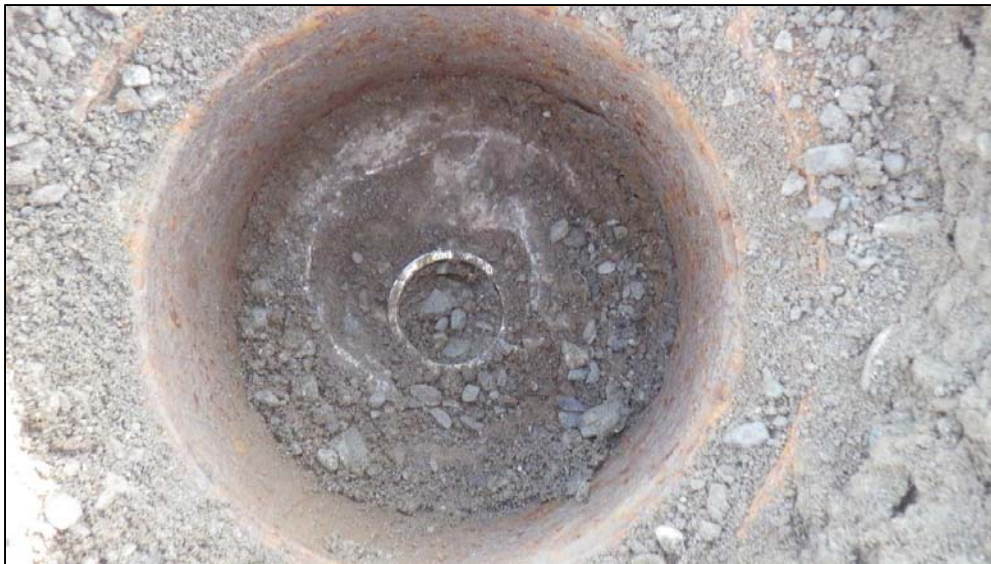
At MW-1/EPM-1, the lid of the flush monument was missing, the PVC well cap was missing, and both the monument and PVC were filled with dirt, bentonite, and debris to the surface. The flush monument and concrete apron were removed, disposed, and the area was backfilled with pea gravel and native material flush with the parking lot surface.

Photograph 12: Monitoring well MW-1 prior to decommissioning.

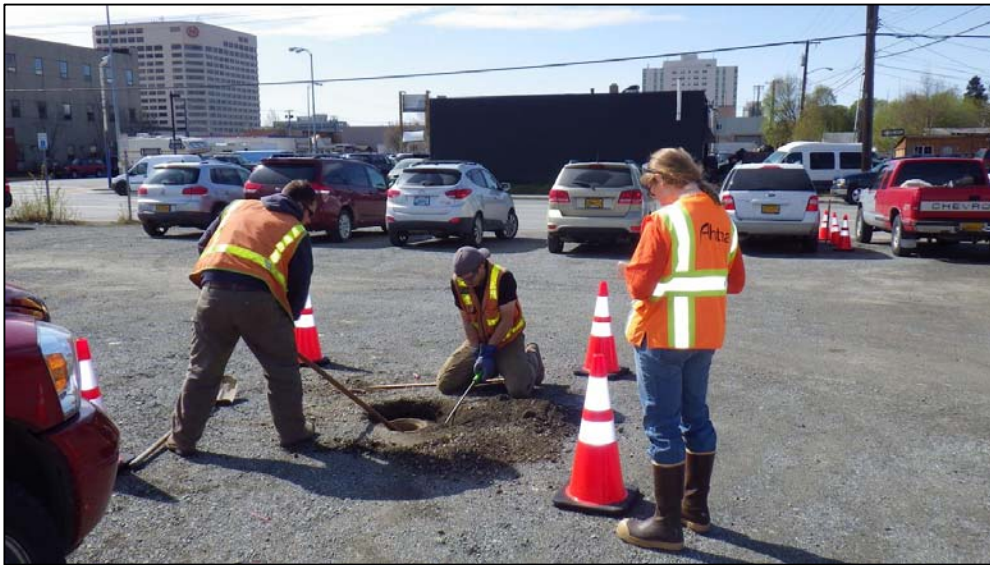
Photograph 13: Decommissioning MW-1. Looking southeast.

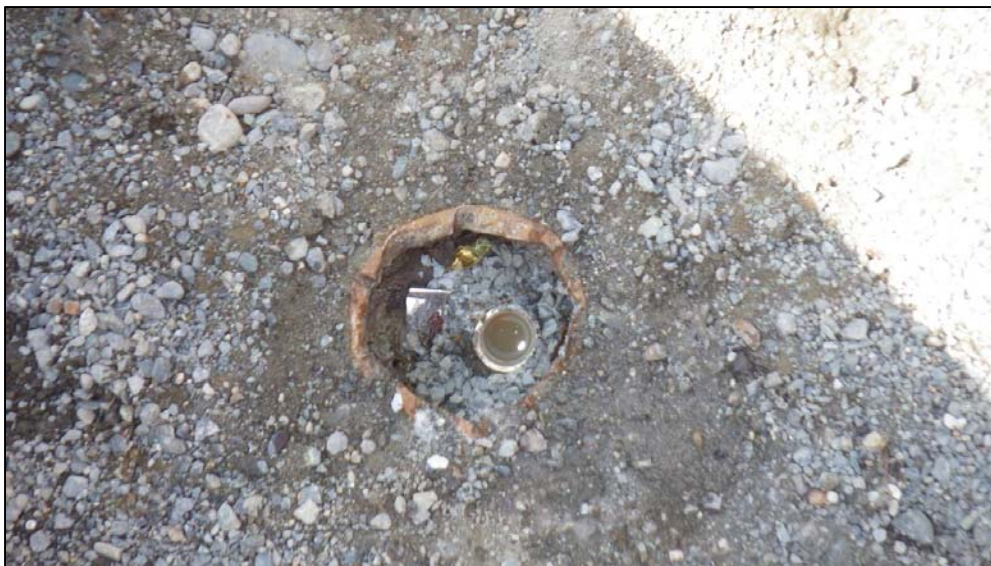
At MW-4, the lid of the flush monument was intact, but the PVC well cap was missing. Only 30 feet of the original 50 feet was clear; the bottom 20 feet of the well, including the screened interval, was filled and the bottom of the well was not able to be removed. The remaining 30 feet was filled with bentonite chips hydrated in place. The flush monument and cold patch apron were removed, disposed, and the area was backfilled with pea gravel and native material flush with the parking lot surface.

Photograph 14: MW-4 condition prior to decommissioning.

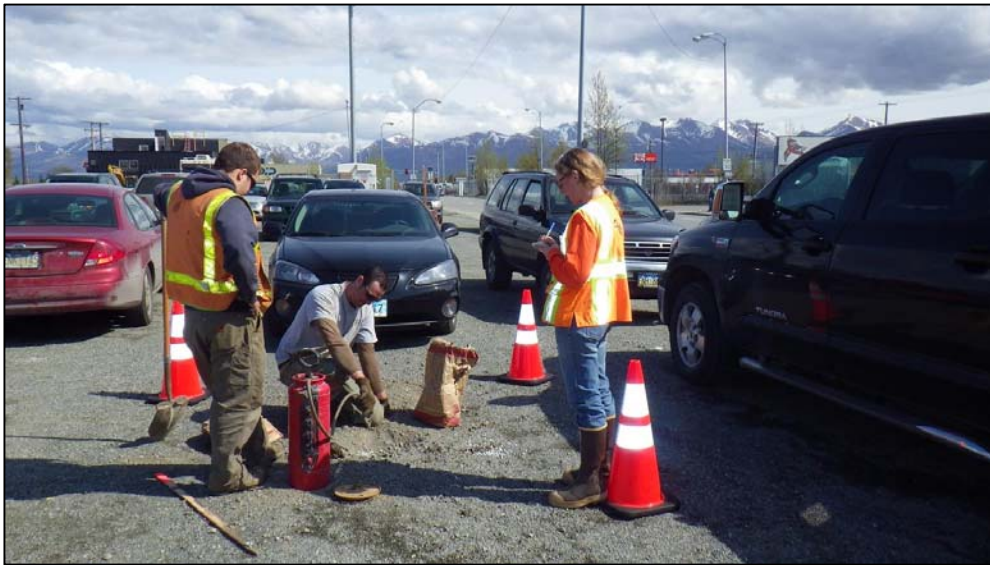
Photograph 15: Decommissioning MW-4. Looking southeast.

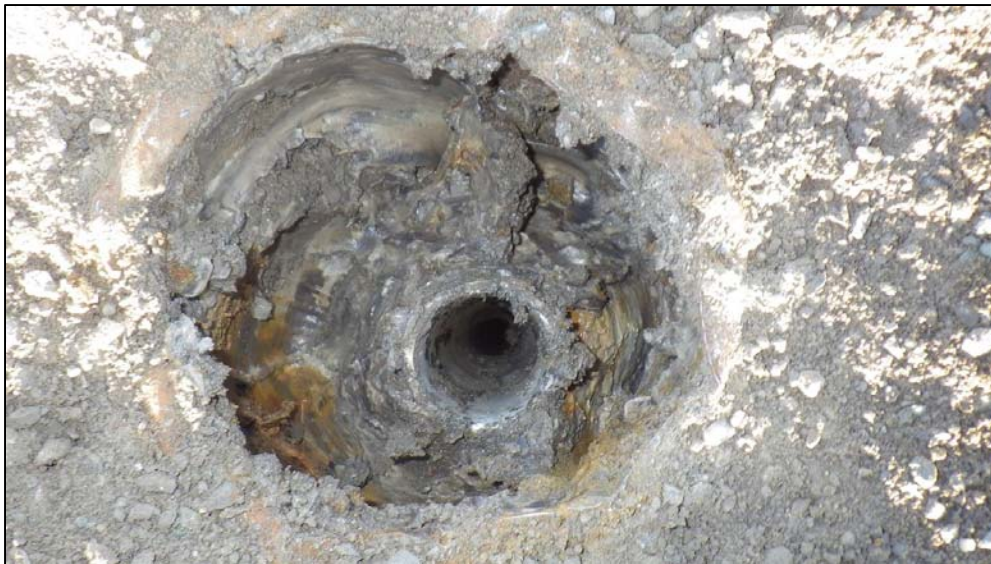
At MW-2, the lid of the flush monument was missing, but the PVC well cap was in place. The monument annulus was filled with dirt and bentonite. Only 15 feet of the original 45 feet of depth was clear; the bottom 30 feet of the well, including the screened interval, was filled and the bottom of the well was not able to be removed. The remaining 15 feet was filled with bentonite

Photograph 16: MW-2 prior to decommissioning.

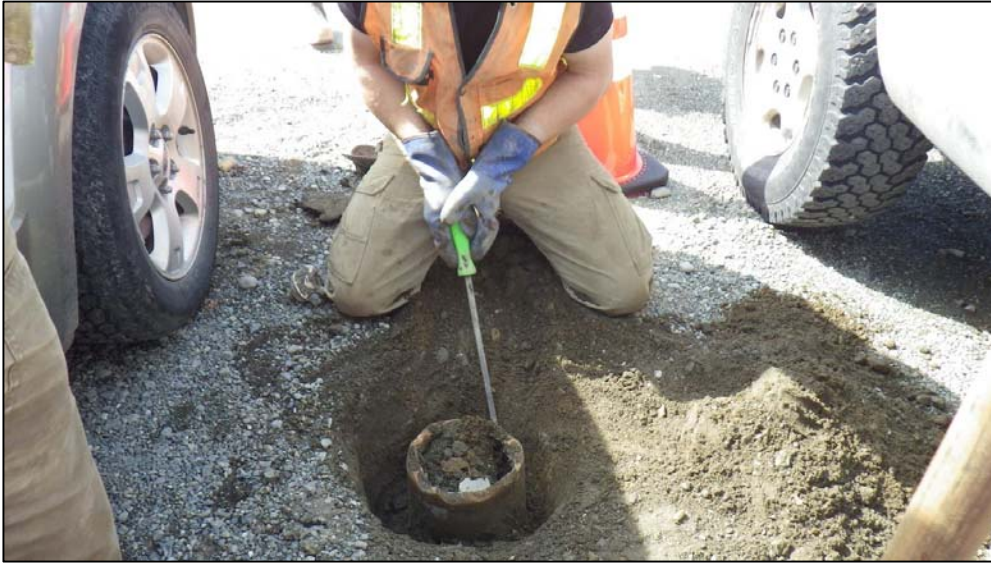
Photograph 17: Decommissioning MW-2. Looking west.
